DREV - TR - 1999 - 137

CHARACTERIZATION OF POTENTIALLY
EXPLOSIVES-CONTAMINATED SITES AT CFB GAGETOWN,
14 WING GREENWOOD AND CFAD BEDFORD

December/décembre 1999

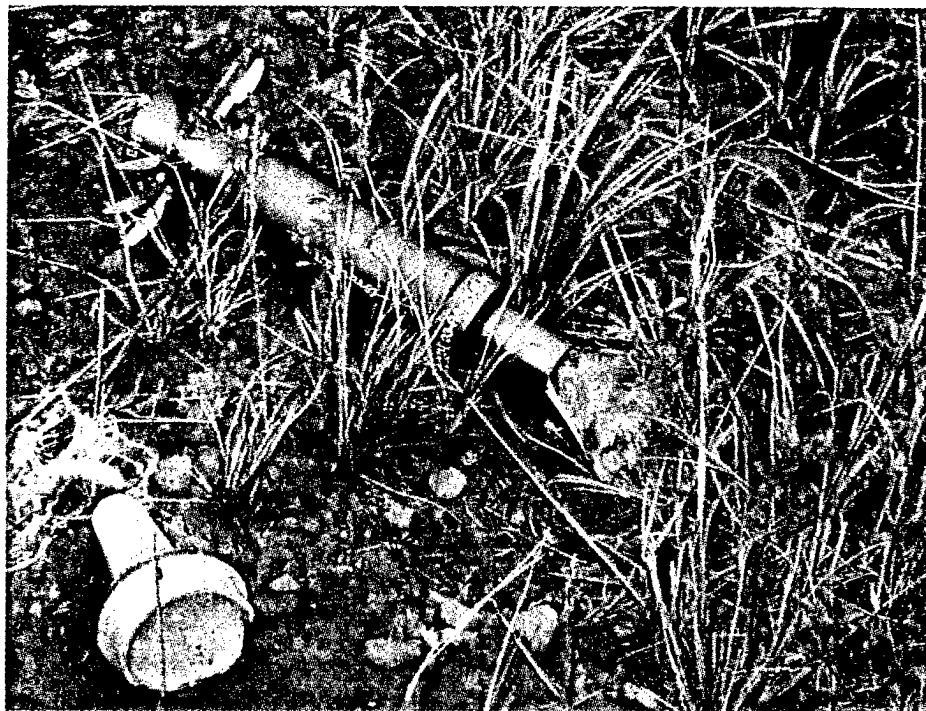
FIGURE 1 – Duds of M72 leaching octol in the environment

According to our past studies (Ref. 10), for the source of contamination of the Wellington Antitank Firing Range the main contamination source suspected for antitank ranges is the M72 ammunition. By having talked to many CF military personnel and by having seen many antitank ranges, we noticed that the M72 antitank ammunition has a very high dud rate. It has been demonstrated at WATC Wainwright, Alberta, Canada that this ammunition can reach more than 50% "dud producing" rate when fired under the best conditions. So, many duds can break when hitting the target or rocks and the explosive melt-cast formulation might be exposed to the environment. A picture of a M72 at WATC Wainwright broken on the ground leaching explosive is shown in Fig. 1. No HMX contamination was found in the sample WX located between Targets W1 and W2, proving that there is less contamination found away from targets.

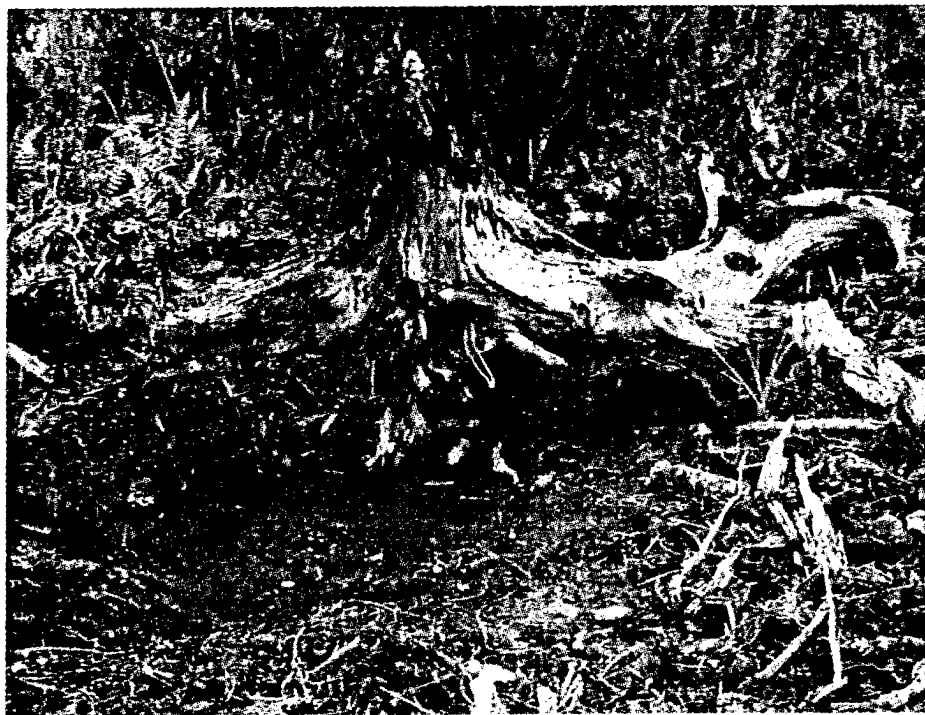
FIGURE 2 – Unexploded M72 in a stump

The explosive contamination found on the surface at those sites is low and negligible, except for the Wellington ATR where we found a high level of HMX contamination on the surface. Thus, we can confirm that the contamination on many ATRs in Canada is due to the M72 weapons system, which has a high dud rate and produces many broken casings that expose the Octol on the ranges, this leads soil and groundwater contamination by HMX and TNT. We would recommend that DND take action in order to minimize this unfortunate impact in the future by causing in the same no inconvenient on training or operations taking place on site. One possible solution that will need to be investigated is the correction of the high dud rate problem of the M72 munitions. On site, we have seen M72 ammunition hit the target directly without having detonated (as shown in Fig. 2).

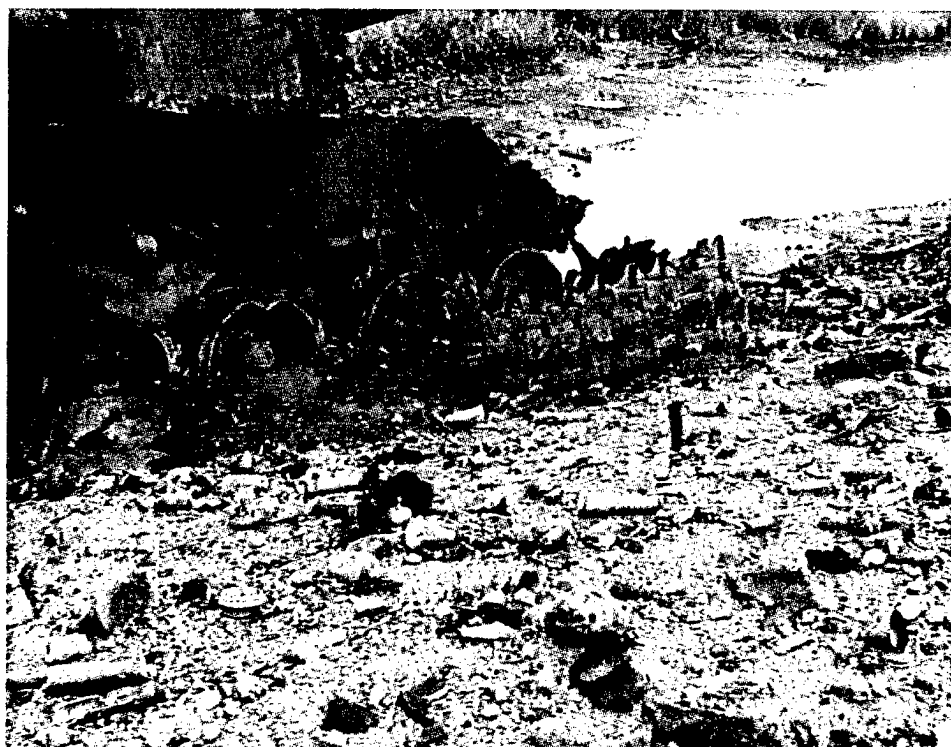
FIGURE 3- Pictures of the Wellington Antitank Range

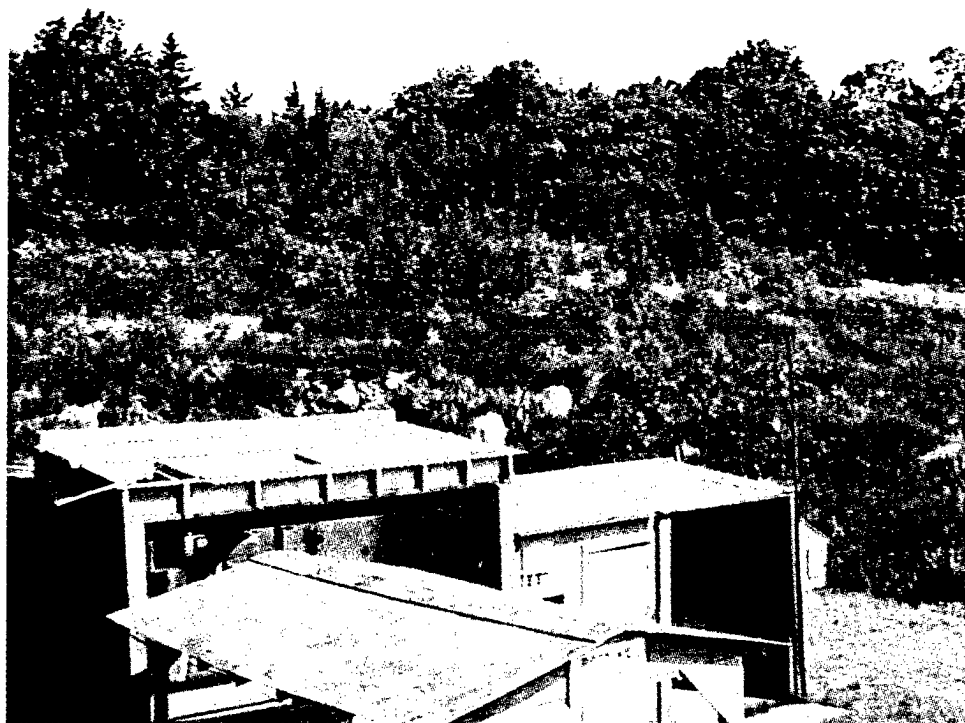
FIGURE 5 – Pictures of the CFAD Bedford site
